# **BLACK LIQUOR RECOVERY BOILER**

## **ADVISORY COMMITTEE**

### **MINUTES OF MEETING**

#### **October 1, 2 & 3, 2007**

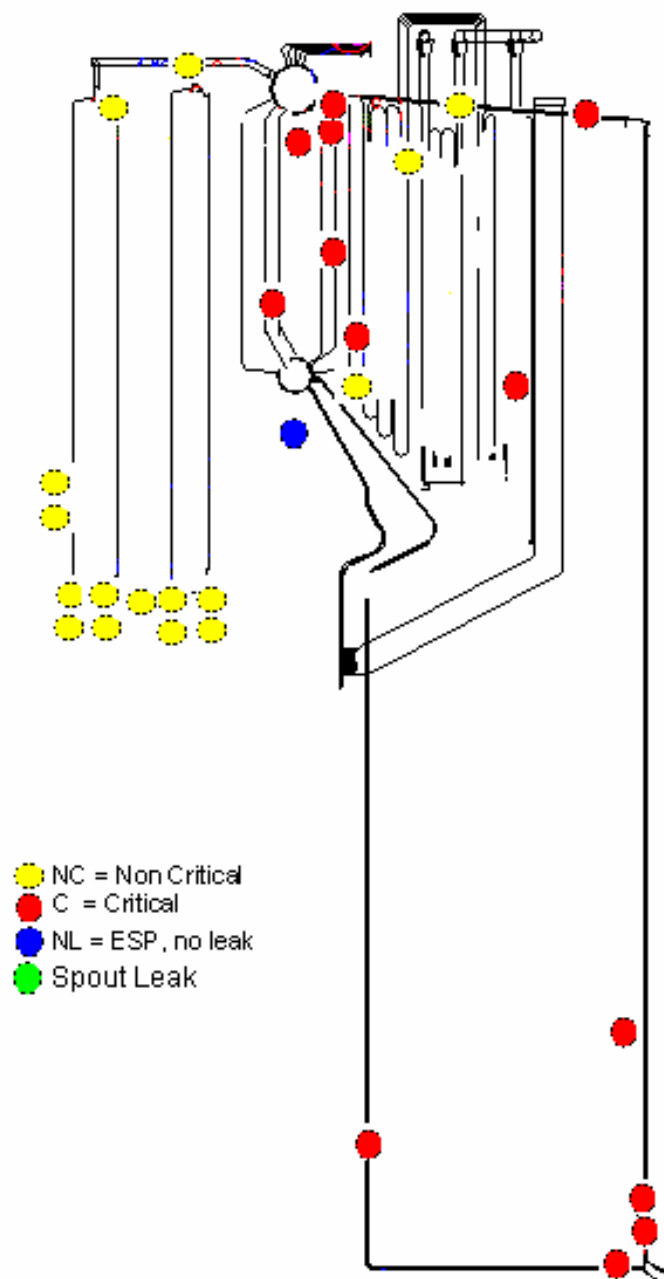
**Figure 1**

The general locations of the leaks for boilers in North America are shown in Figure 1, which displays a typical boiler, not representing any particular style or model. The yellow marks are the non-critical incidents, the red were listed as critical incidents and the blue mark indicates an ESP with no leak. The leaks locations are summarized as follows:

- 13 – Economizer
- 2 – Superheater
- 3 – Boiler Bank
- 1 – Furnace Screen
- 9 – Wall Tubes
- 1 – Floor Tubes
- 0 – Smelt Spout
- 1 – ESP w/ no leak

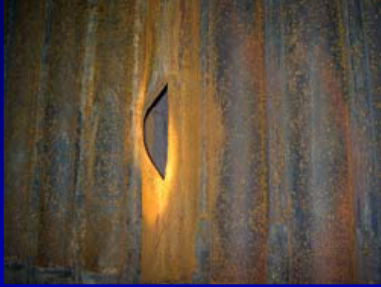
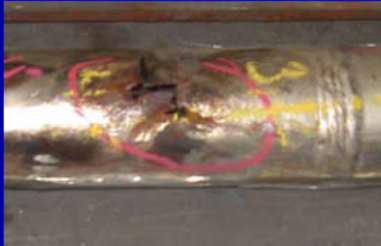
## Two furnace tube leaks 1/2006

- Furnace leaks
- 4 in. hole in the furnace tube
  - another hole in the same tube 39 feet lower caused by hydrogen corrosion
- Down time 121 hours

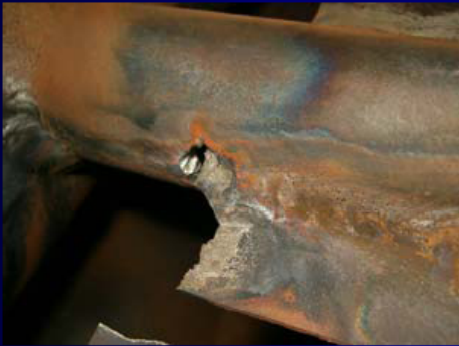
## Incidents 9, 10, and 11/2006

- All the incidents in the same recovery boiler
  - At the economizer
  - In the furnace wall tube
  - At the screen
- Discovered at the same time during the repairing of the first damage

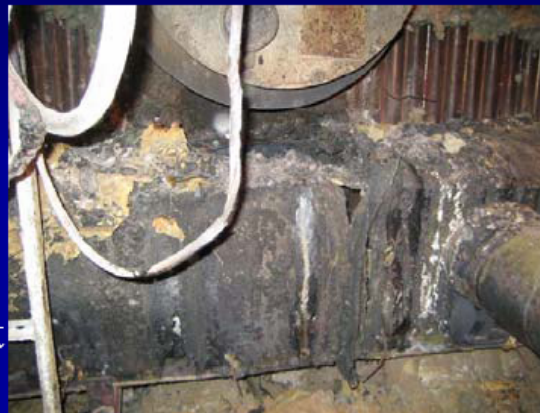
## DNCG duct damage 1/2007

- Start-up going, DNCG directed to the stack
- Deposit on the bottom of the DNCG duct caught fire
- Both the insulation material and the sheet plates near the DNCG nozzle burned

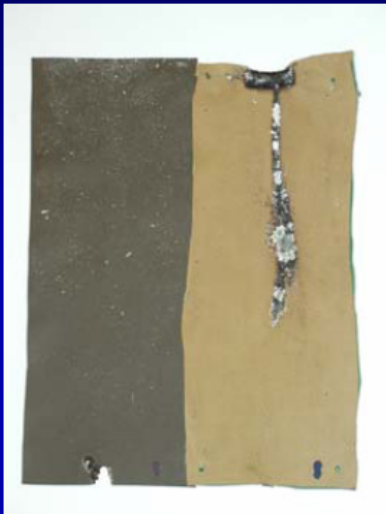
## Background – preliminary study in 2003

- Standard type of heat protective clothing
  - Hot smelt burned the fabrics tested and PVC-skin melted causing third degree burns
- Multilayer materials
  - First degree burns
    - Multilayer firemen's material
    - Leather
