BLACK LIQUOR RECOVERY BOILER ADVISORY COMMITTEE

MINUTES OF MEETING Crowne Plaza Hotel/Atlanta Airport October 24, 25 & 26, 2016

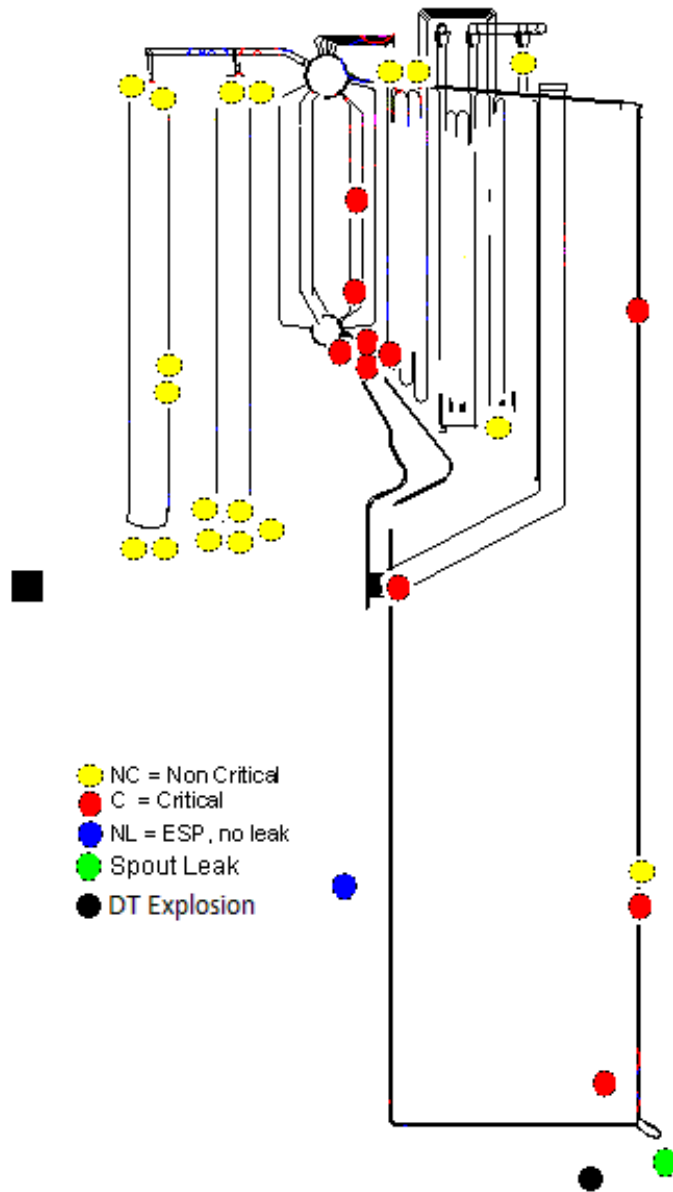
Figure 1

The general locations of the leaks for boilers in North America are shown in Figure 1, which displays a typical boiler, not representing any particular style or model. The yellow circles are the non-critical incidents and the red circles indicate the location of the critical incidents. The two green dots are for the Spout Leak

Fall 2016 Incident Locations

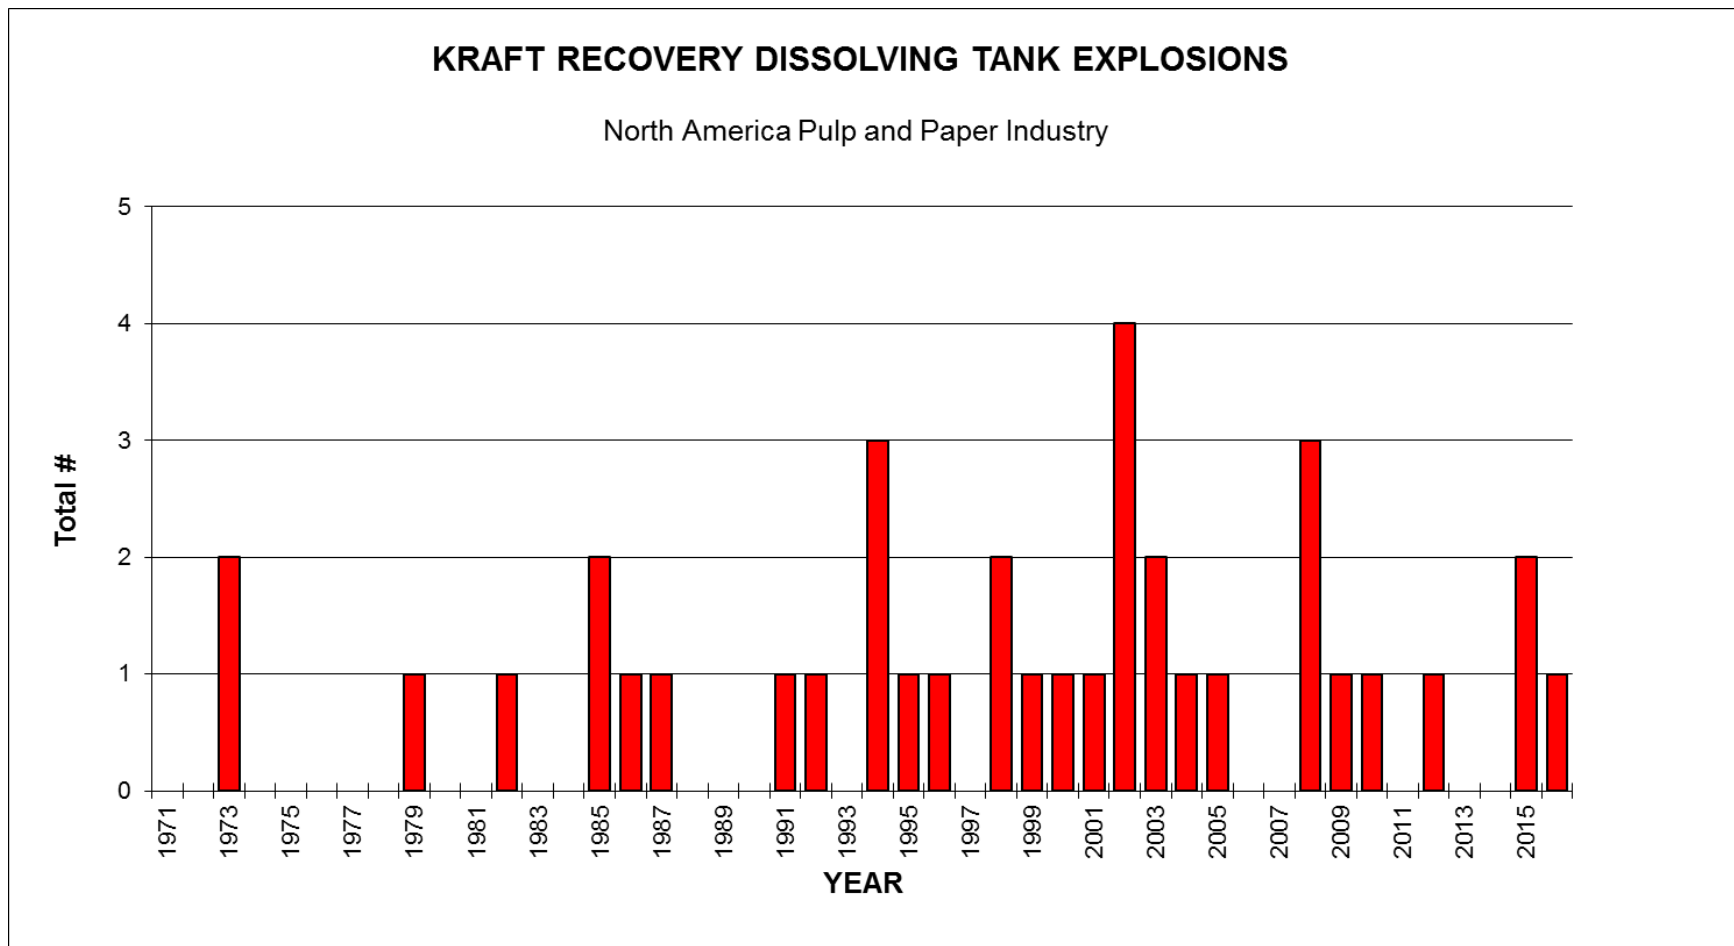
Figure 4 shows the history of reported dissolving tank explosions with the two that were reported last year and one this year. Following the recommendations from Section 10 of the Safe Firing of Black Liquor document would prevent many of the reported dissolving tank incidents that have occurred in the past.
