# BLACK LIQUOR RECOVERY BOILER

## ADVISORY COMMITTEE

### MINUTES OF MEETING

#### March 26, 27 & 28, 2007

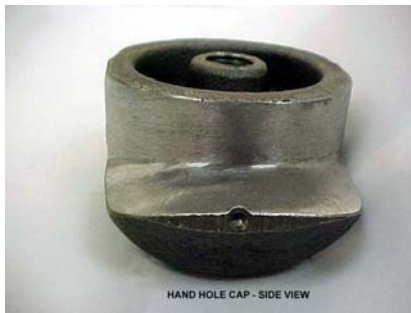
Slide - 2

### Some Folks- “Upset” Along the Side of Caps

**Why “Upset” the Caps??**

**For Shrinkage Allowance of Weld Metal.**

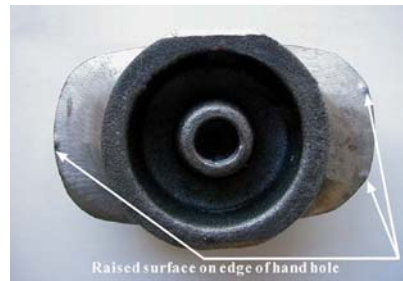
Slide - 3

### 3 Raised Points Along the Edge

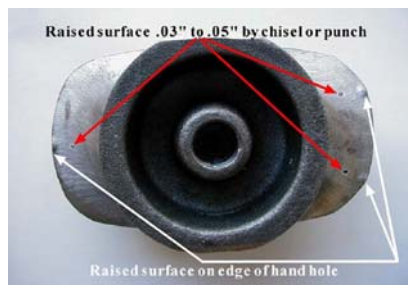
Slide - 4

### But Not Both Surfaces
