BLACK LIQUOR RECOVERY BOILER

ADVISORY COMMITTEE

MINUTES OF MEETING Crowne Plaza Hotel/Atlanta Airport Atlanta, Georgia October 6, 7 & 8, 2008

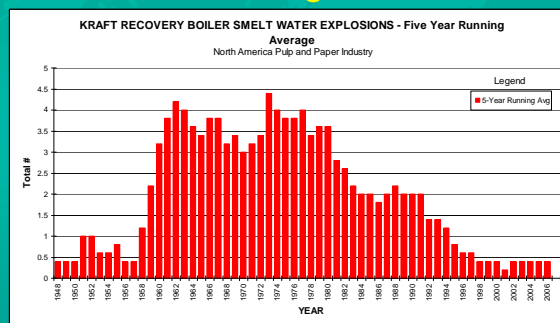
Explosion History - Five Year Avg.

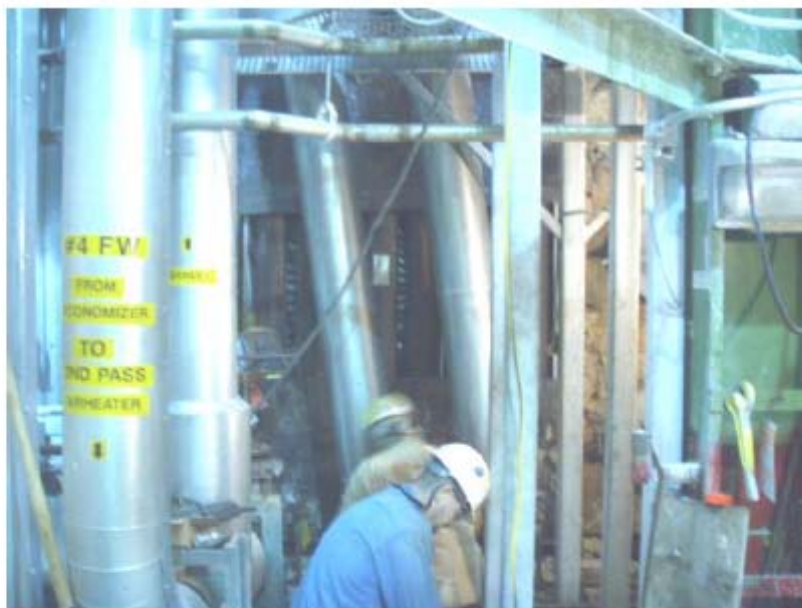
Right Side of Heater –
Lagging and casing
removed over header
areas near leaking tube

Header side
and
crossover piping side

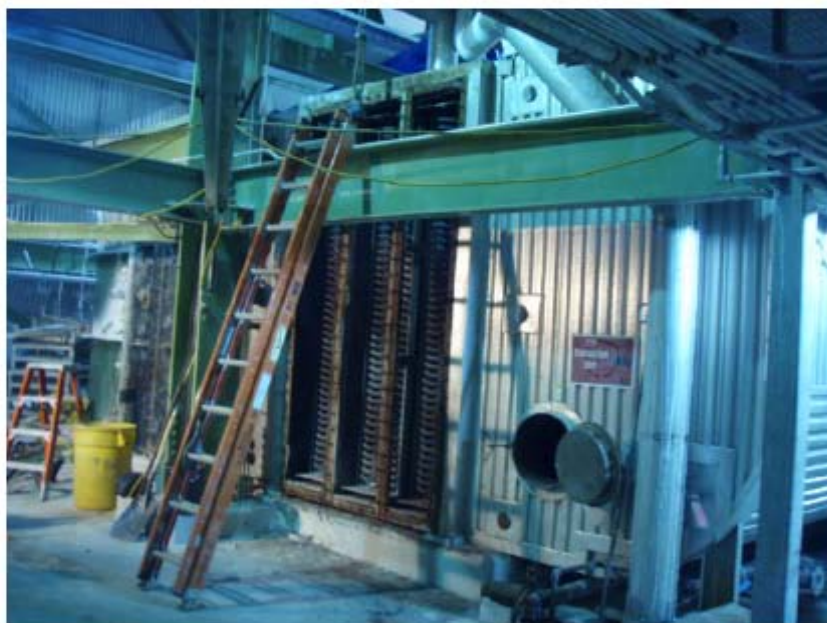
Left Side of Heater

Return bend side

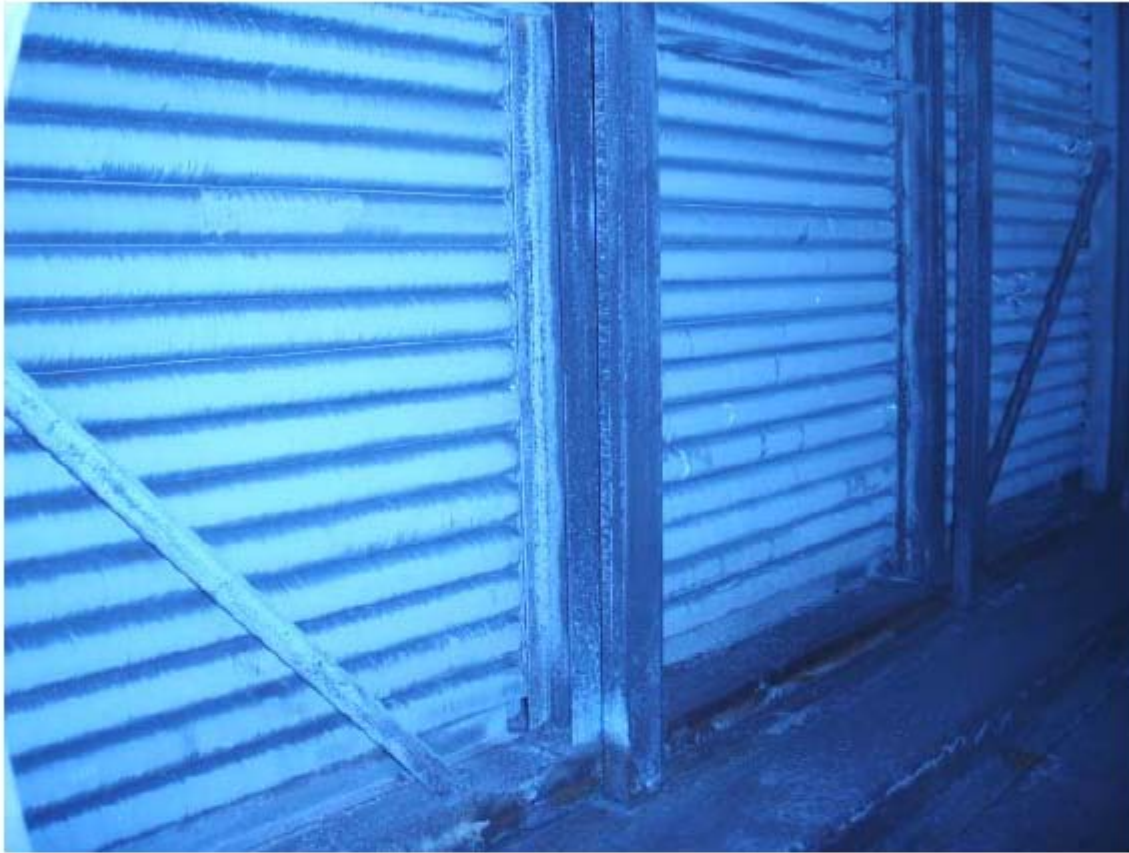
View of the FD Air side of the heater – showing the finned tubes, this is the outlet side of the heater as viewed from the front left lower man access door

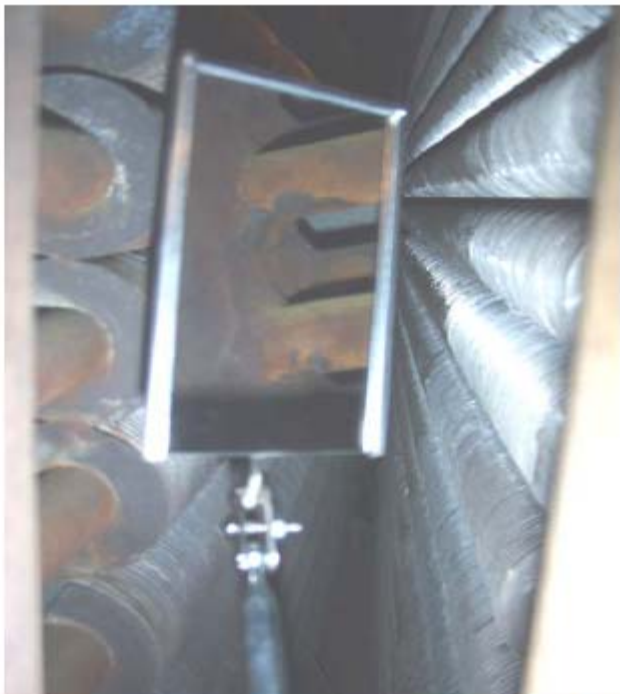
<p>Looking between the feed and return headers, View from the right side – shows the tube to header manifold welds.</p>

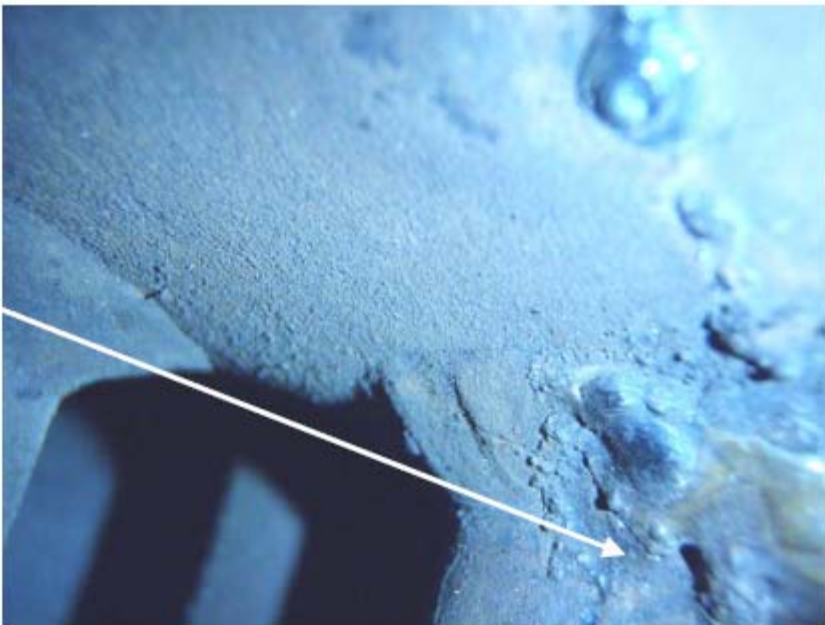
<p>Tube to header weld close up of the leak site, after failed attempt to weld from gas side. The attempt was made with a mirror, and unsuccessful. The unit was isolated and repaired days later.</p>

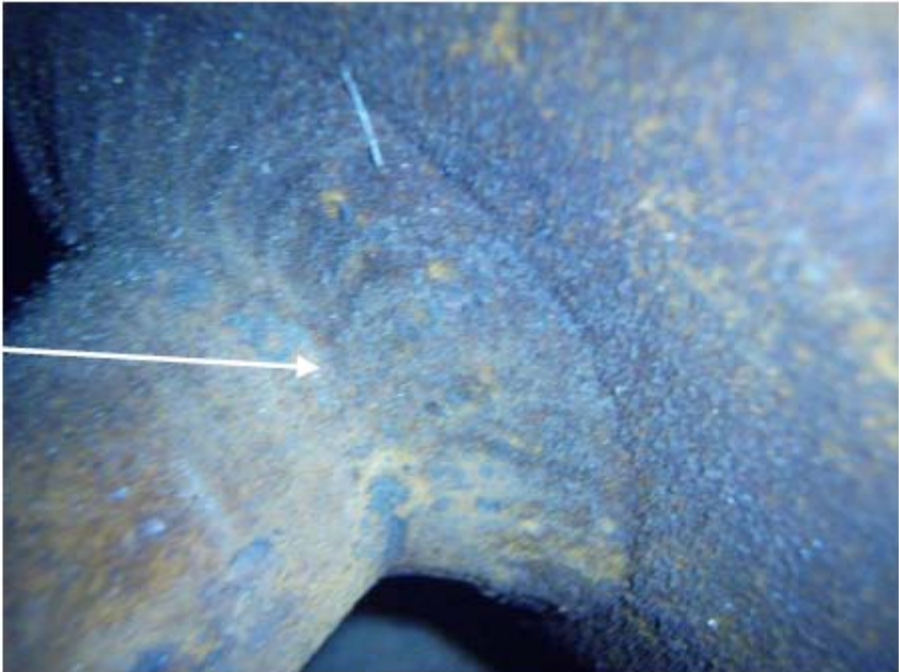
<p>Close up view of tube to header weld – gas side</p> <p>Toe of weld on tube side that is the leak prone area.</p>

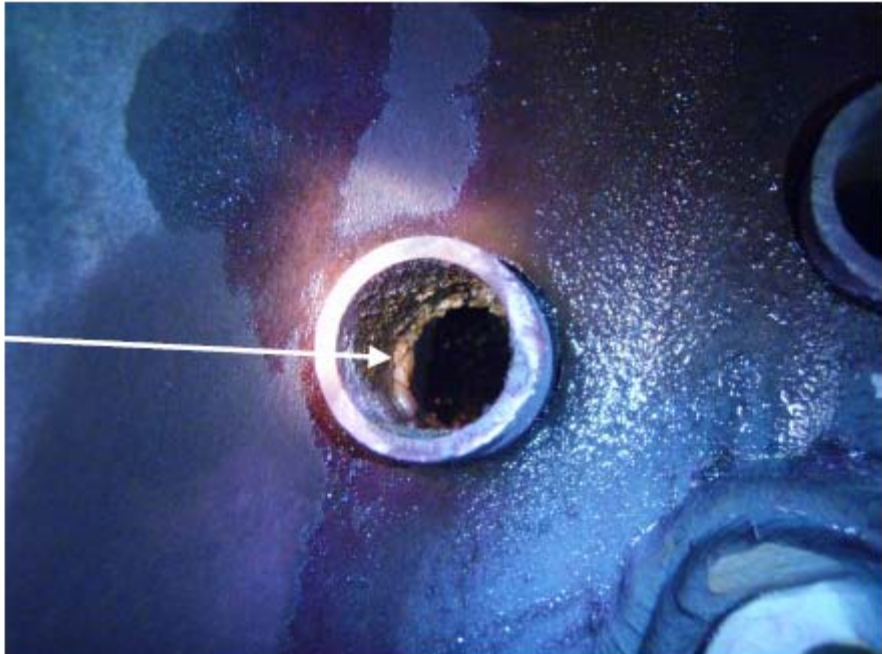
<p>Internal protrusion into tube – result of melt thru from tube to header shop weld</p>

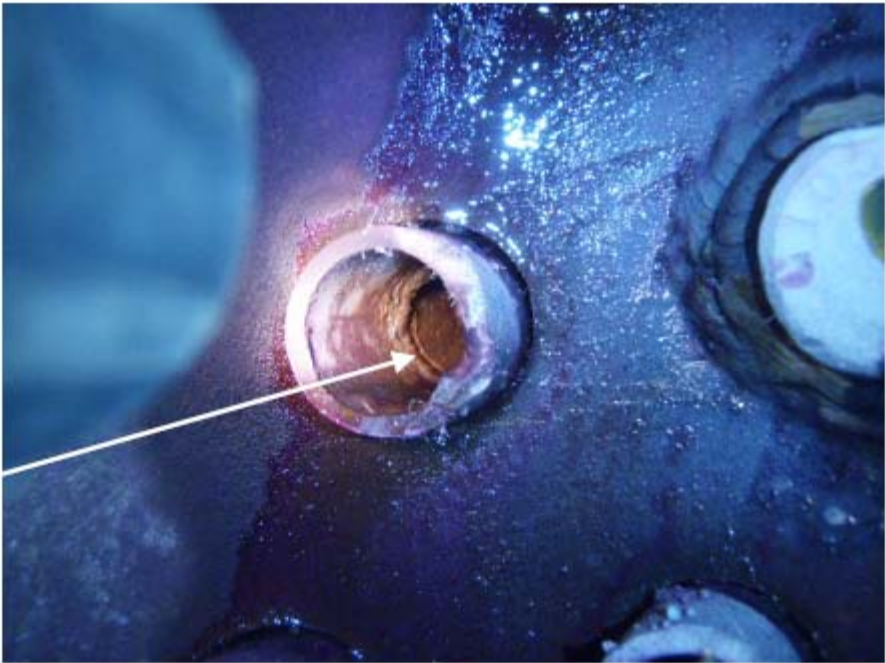
<p>Another tube with internal burn thru, resultant of weld from outside of pressure part –</p> <p>NOTE: indication of active corrosion (bright orange) this linear indication appears to be a crack.</p>

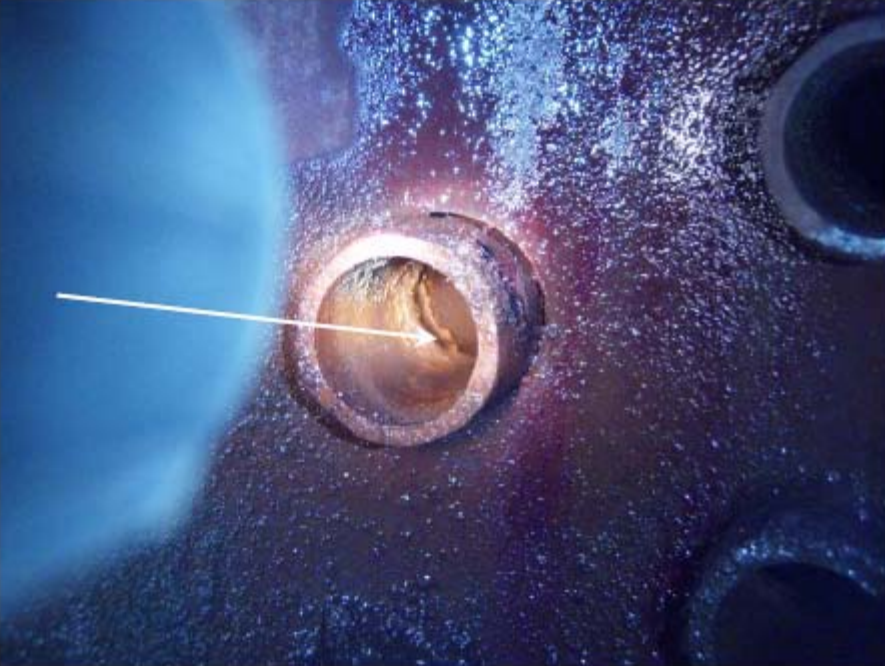
<p>Another tube with internal burn thru, resultant of weld from other side of pressure part –</p> <p>NOTE: indication of active corrosion (bright orange) this linear indication appears to be a crack.</p>

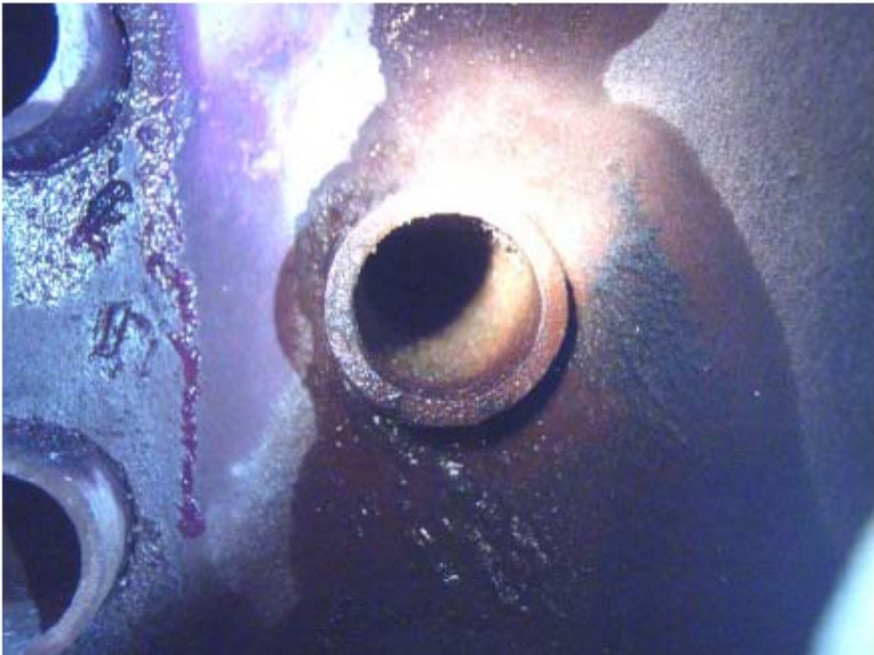
<p>Tube ID with no signs of internal weld related tube ID remelt or internal protrusion.</p>

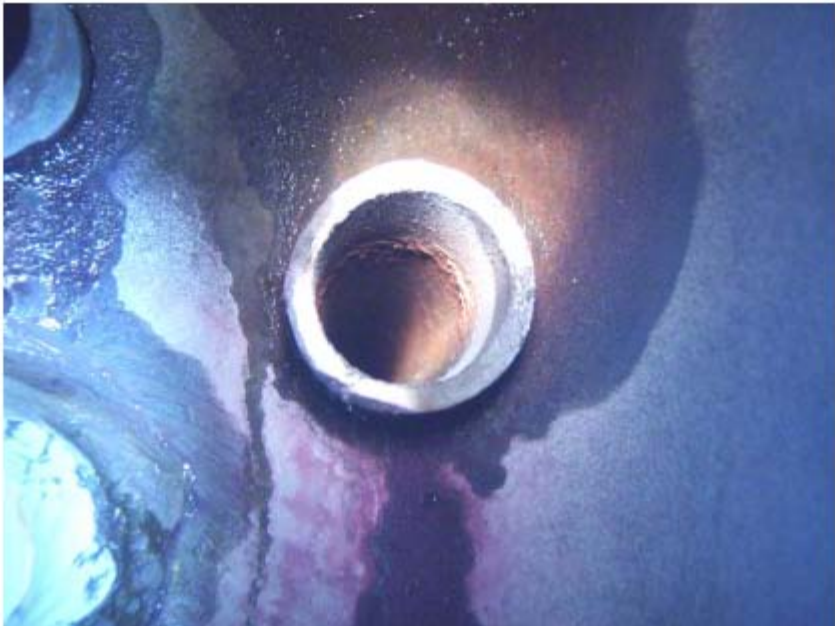
<p>Tube ID with minor amount of internal melt – called a “heat line”</p>

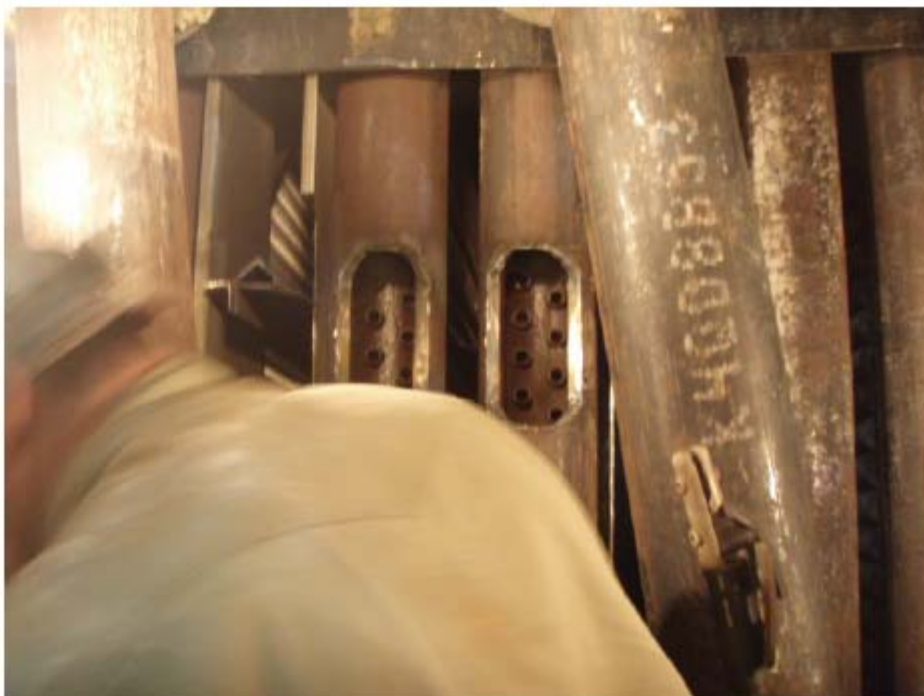
<p>Header side (Right side of boiler setting) of unit was opened up and access to the tubes was cut into the feed and return headers -</p>

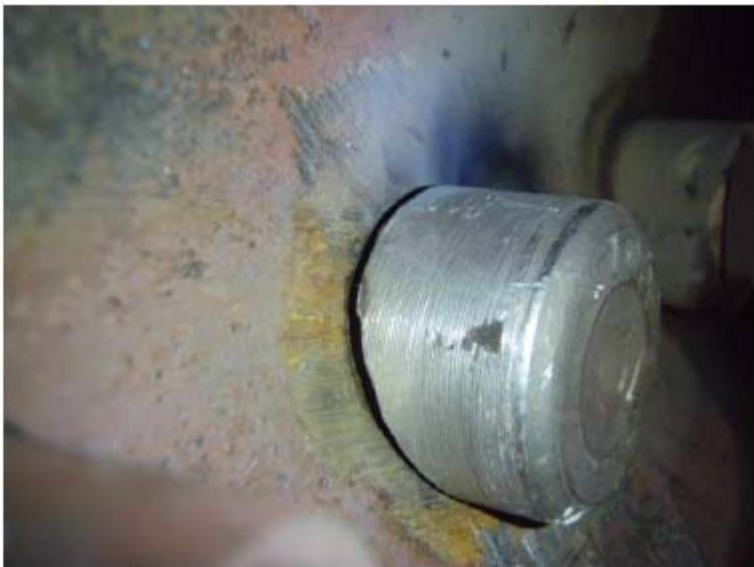
<p>Header plug – machined from SA105 FS pipe fitting</p>

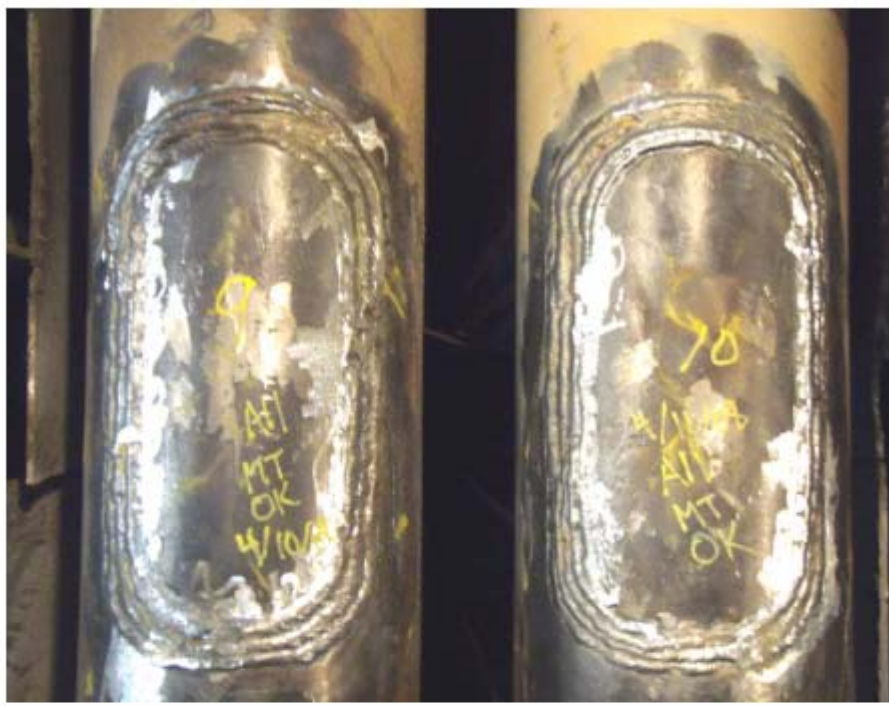
Header sections
welded back into
place and NDE –
MT Examined
prior to pressure
testing
