BLACK LIQUOR RECOVERY BOILER

ADVISORY COMMITTEE

MINUTES OF MEETING

October 7, 8 & 9, 2013

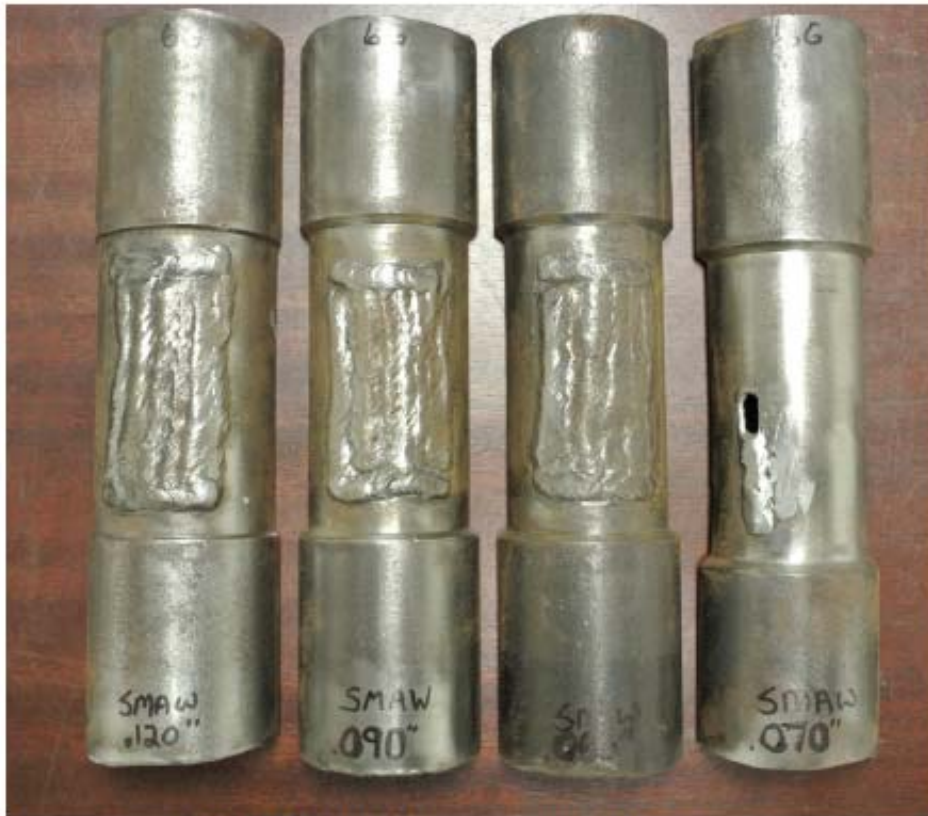
OD: Carbon Steel (P1) *SMAW (Stick) process with E 7018 - 3/32"* was used on these samples. The Weld Progression was Uphill. On all 4 of these samples the Welder Burned-thru the base metal, as the samples got thinner, the Burn-thru was more frequent.

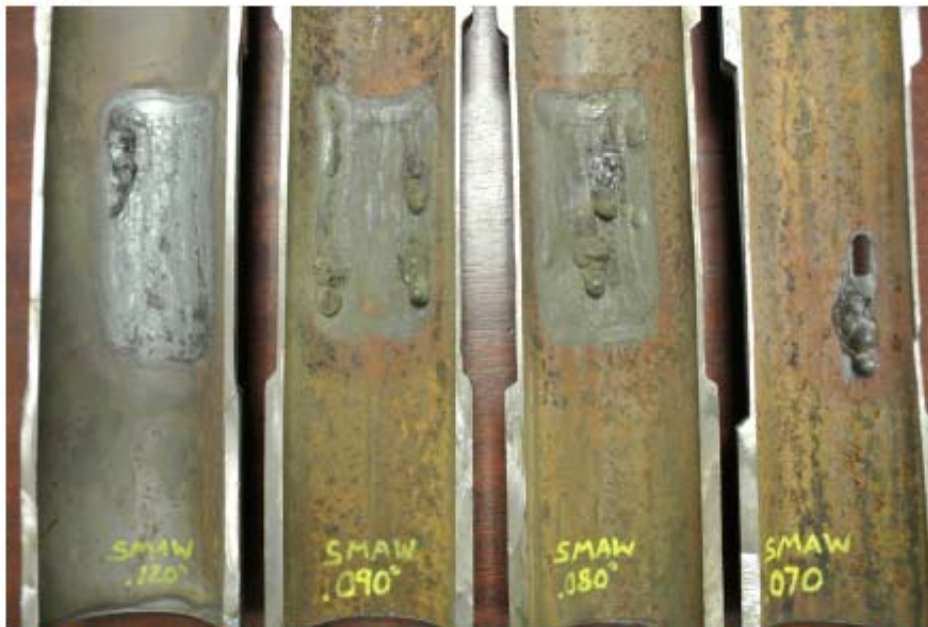
ID: Carbon Steel (P1) The Burn-thru that you see here is not "Melt-thru" it is "Burn-thru." Holes were actually burned in the base metal and filled back up with the SMAW process as the Welder was welding. Note: .070" sample was too thin to Weld.

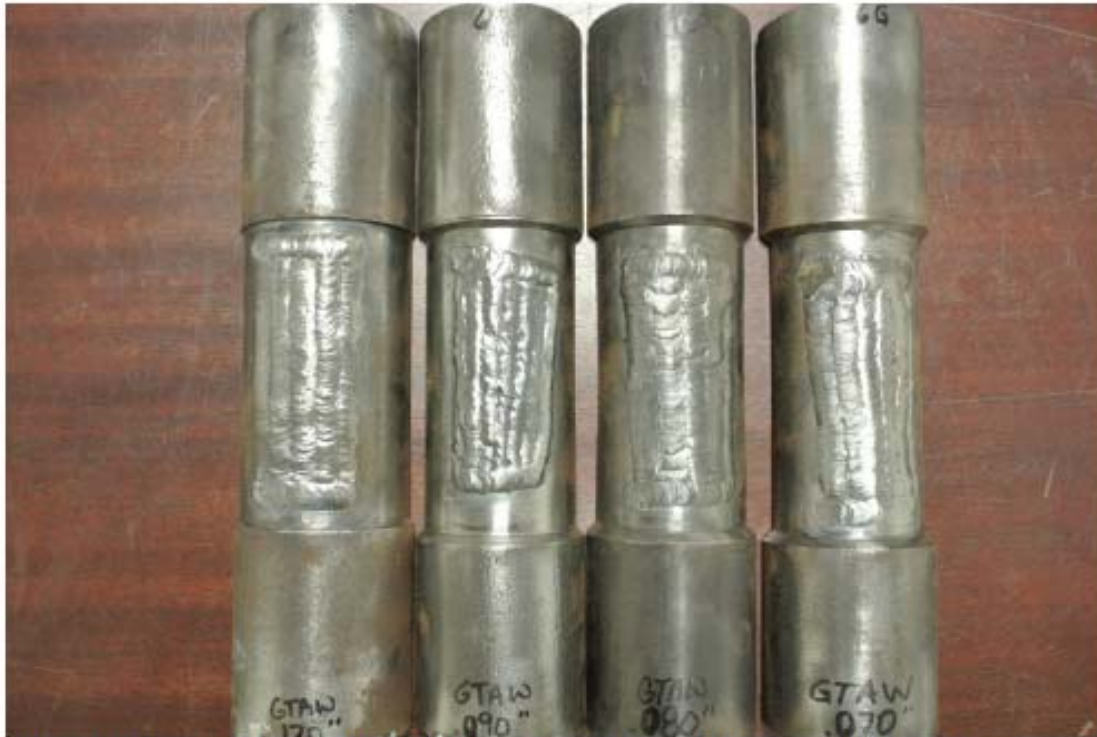
OD: Carbon Steel (P1), GTAW (TIG) process with E 70 S2 - 3/32" was used on these samples. The Weld Progression was Uphill. On all 4 of these samples the Welder Melted-thru the base metal, as the samples got thinner, the Melt-thru was more frequent and excessive.

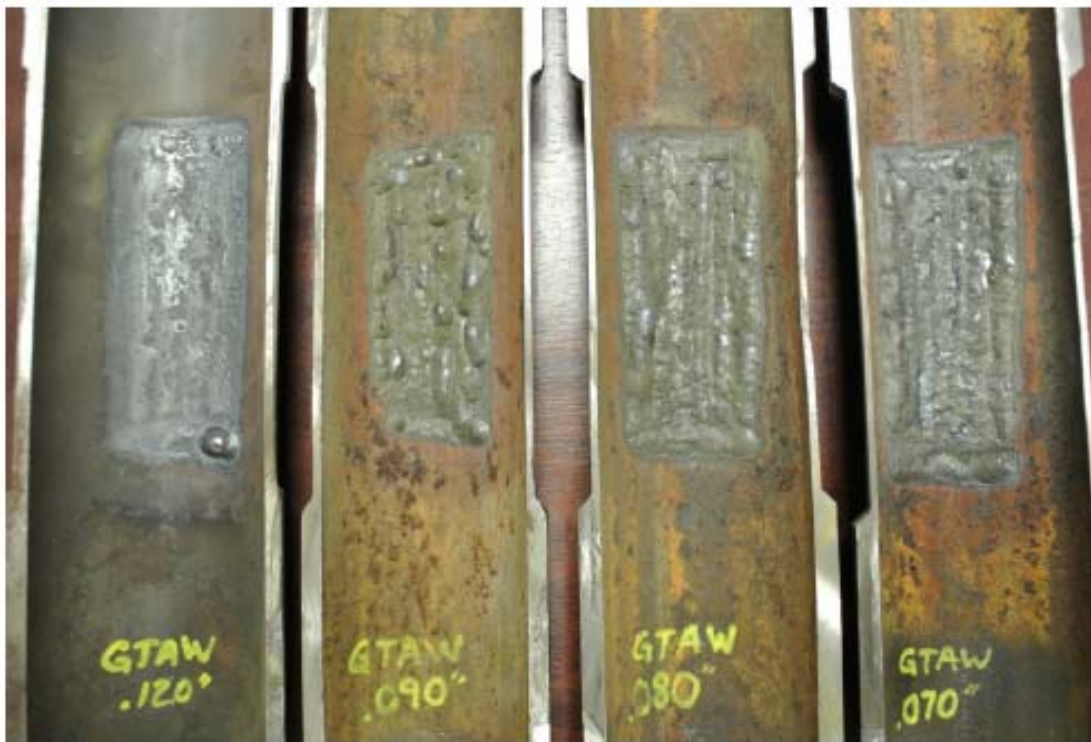
ID: The Melt-thru here is very excessive on the .090", .080" and .070" Samples

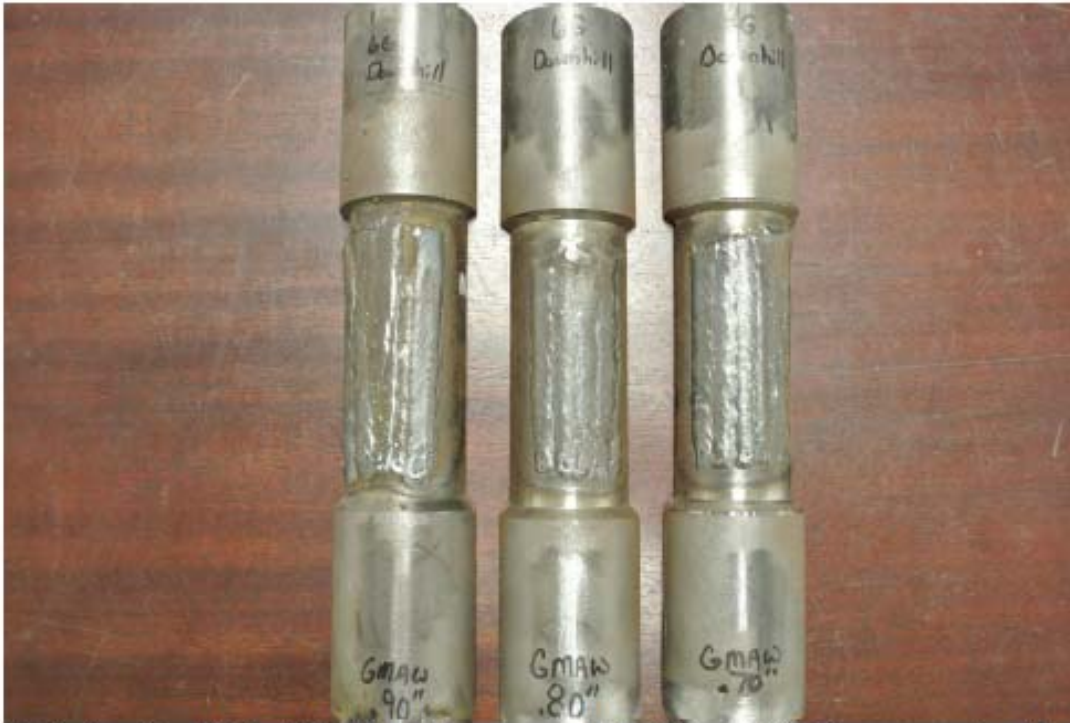
OD: Carbon Steel (P1), GMAW (MIG) process with E 70 S2 - .035" Wire was used on these samples. The Weld Progression was Downhill. Uphill is **not** recommended. On all of these samples the Welder had very minimal Melt-thru on all thicknesses of the base metal. The GMAW Process requires the base metal to be very clean. When applying Weld Build Up on Tubes of approximately .120" and below, GMAW (MIG) is the preferred method for Weld Build UP.

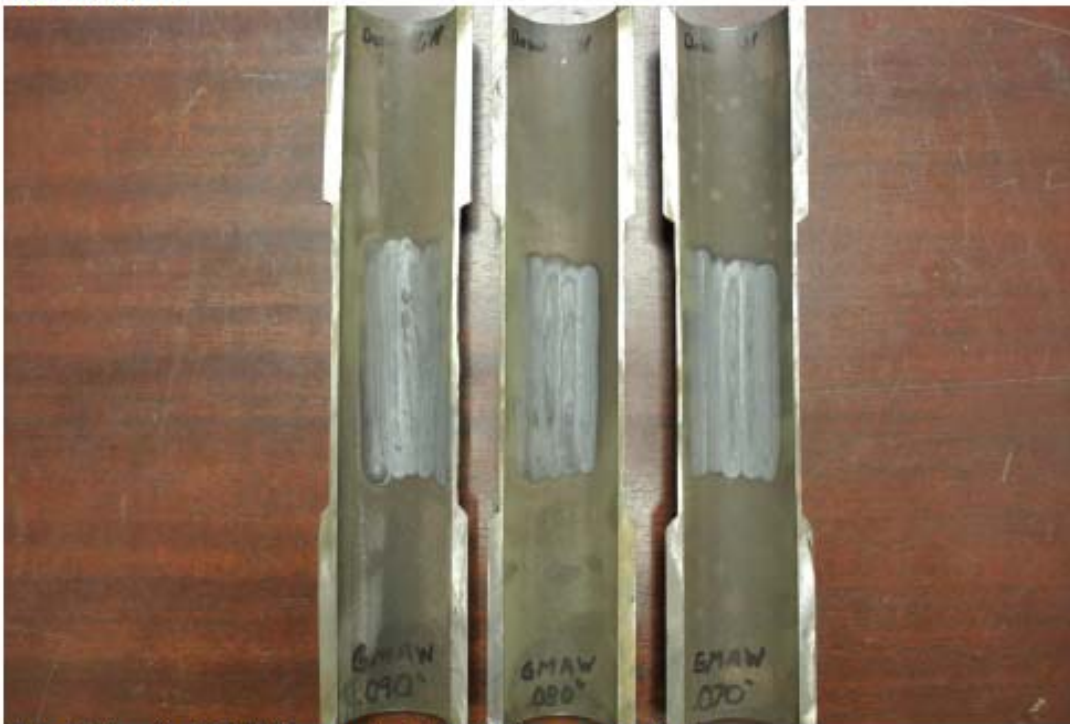
ID: Notice the Melt-thru on the Tube ID is very minimal.

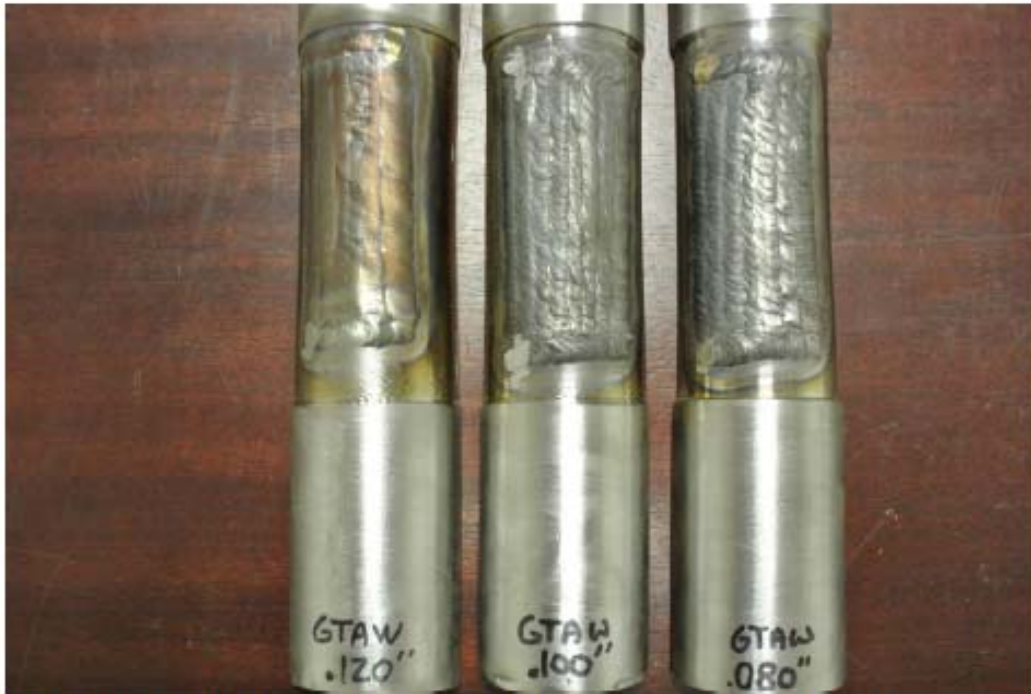
OD: **Stainless:** GTAW (TIG) process with E 316L - 3/32" was used on these samples. The Weld Progression was Uphill. On all 3 of these samples the Welder Melted-thru the base metal, as the samples got thinner, the Melt-thru was more frequent and excessive.

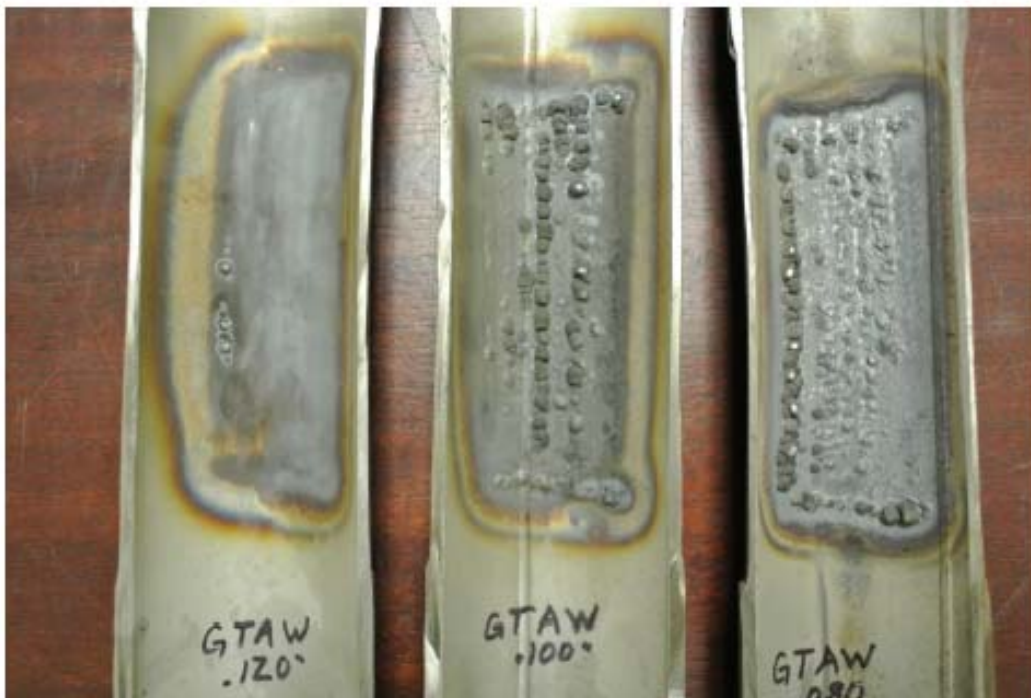
ID: **Stainless:** The Melt-thru on the .100\" & .080\" thick samples was excessive and "Sugared" (oxidized) the ID of the Tube. This is because the ID of the Tube is not accessible to use a Backing Gas such as Argon to shield the base metal or weld area.

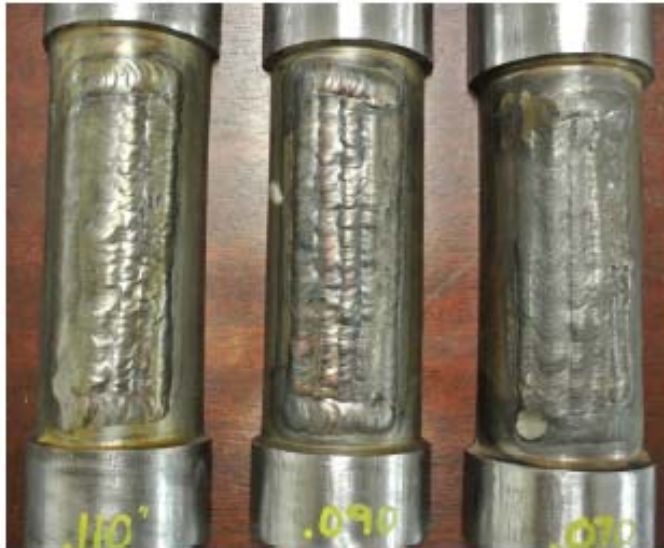
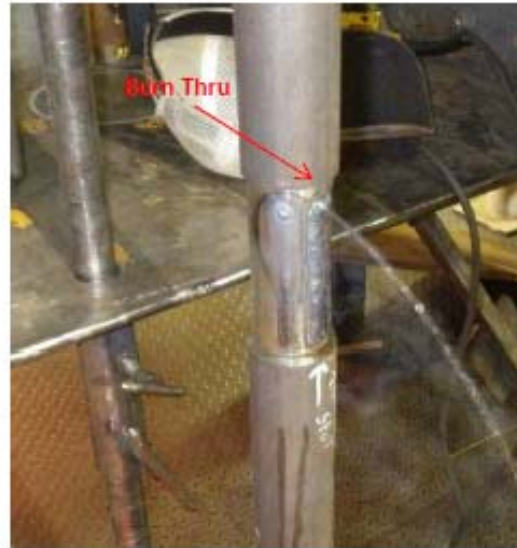
OD: 1-1/4 Chrome (P4), SA 213 T11: *Superheat Tube Simulation* (with Water in the Tube). GTAW (TIG) process with ER 80S B3- 3/32" was used. The Weld Progression was Uphill. Welder Burned-thru the base metal once on the .090" sample and multiple times on the .070" sample.

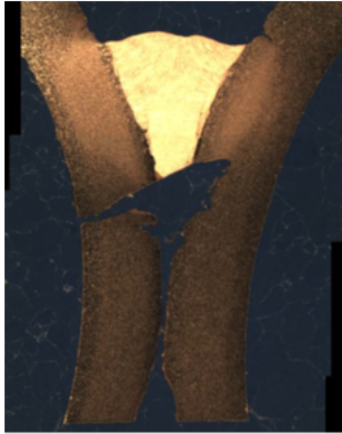
Figure shows a montage of the stitch weld cross-section between tubes #7 and #8. Tube #7 is the sample section on the left with the through wall crack. The yellow arrows point to the indications at the cap of the stitch weld that would be detected during an inspection of the screen tube section using typical inspection methods (visual, PT, MT). The failure would not have been detected by any of these methods. Magnification 6.7x.
