# BLACK LIQUOR RECOVERY BOILER

## ADVISORY COMMITTEE

### MINUTES OF MEETING

#### October 14, 15 & 16, 2019

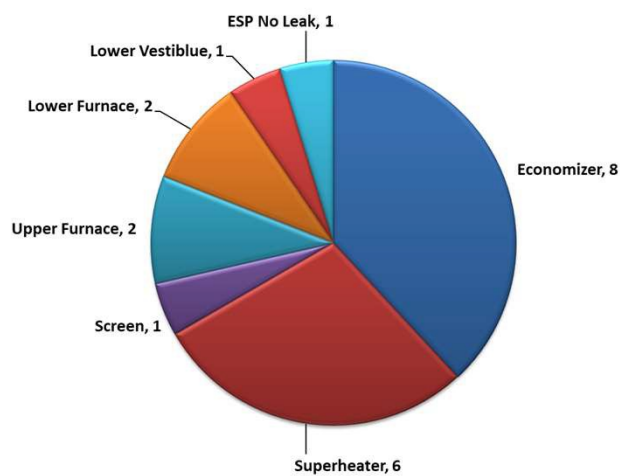
## Incident Locations

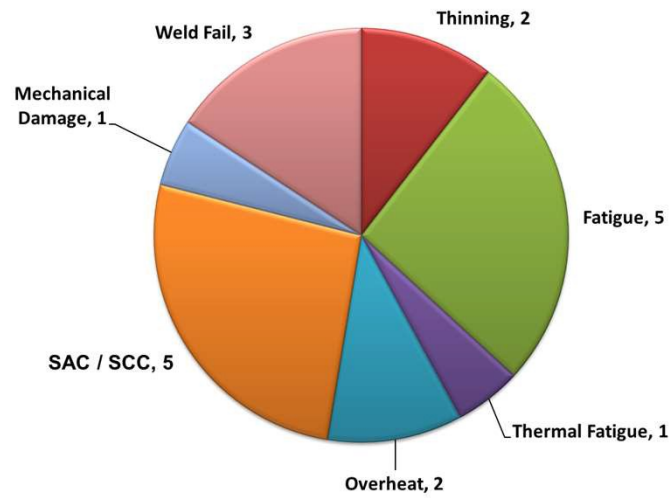
## Leak Cause

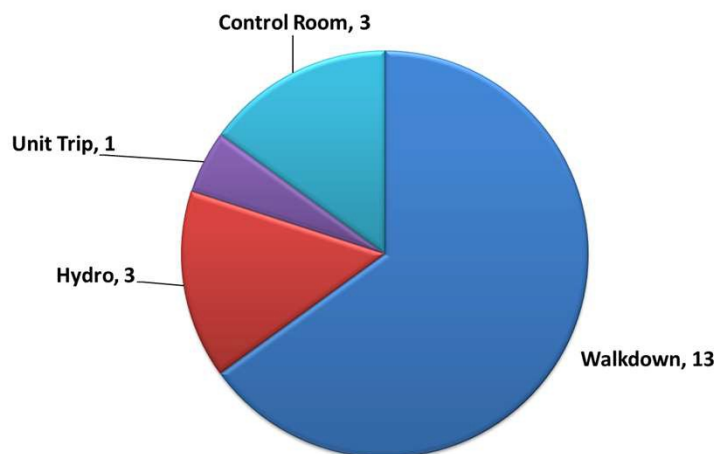
## How Discovered

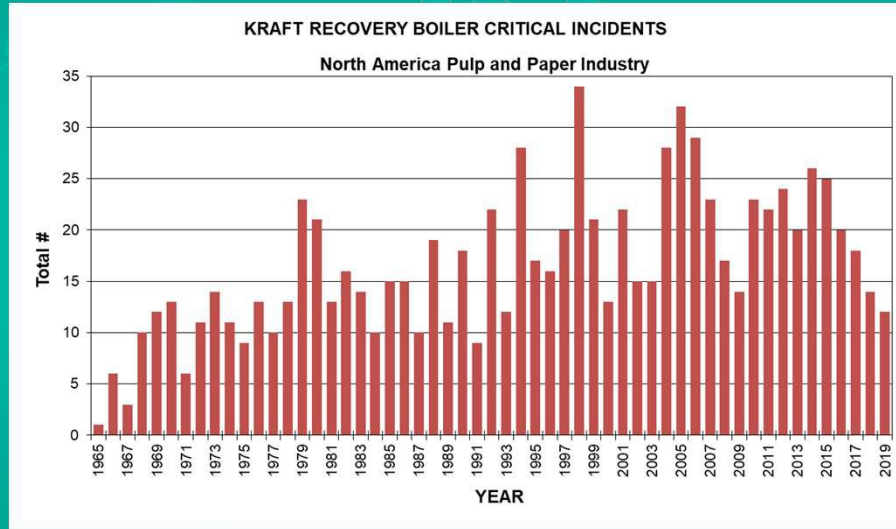
## Critical Incidents to Date

Figure 8 shows the Critical Incidents reported each year. There were 5 reported this meeting which brings the total for the year to 12. Figure 9 shows the history of Recovery Boiler Explosions showing the last reported smelt water explosion in 2017.

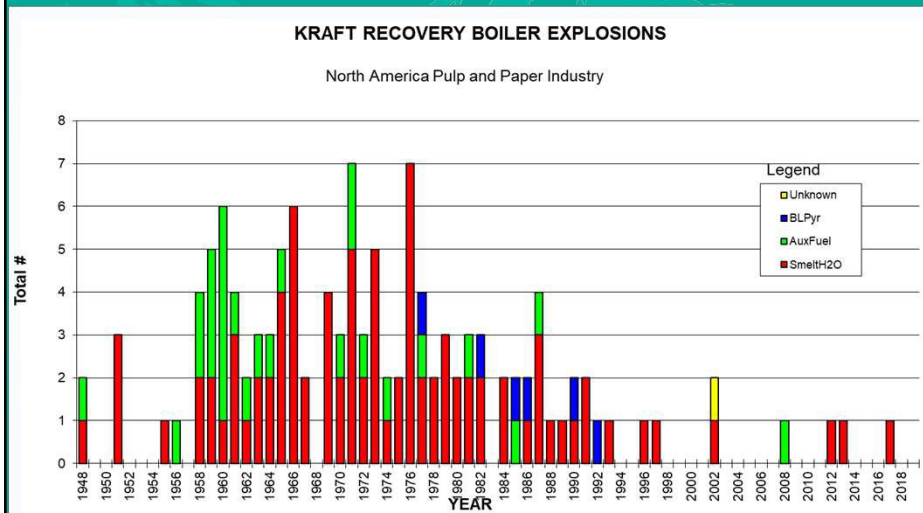
## Boiler Explosion History

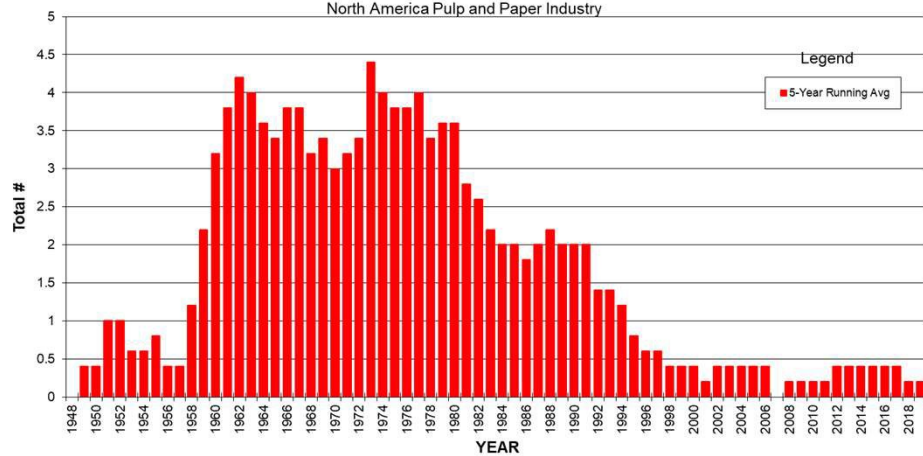
## KRAFT RECOVERY BOILER EXPLOSIONS - Five Year Running Average

North America Pulp and Paper Industry

Figure 11 the five-year rolling average which is now at 0.2 indicating only one explosion in the last 5 years.
