BLACK LIQUOR RECOVERY BOILER

ADVISORY COMMITTEE

MINUTES OF MEETING

October 5, 2022

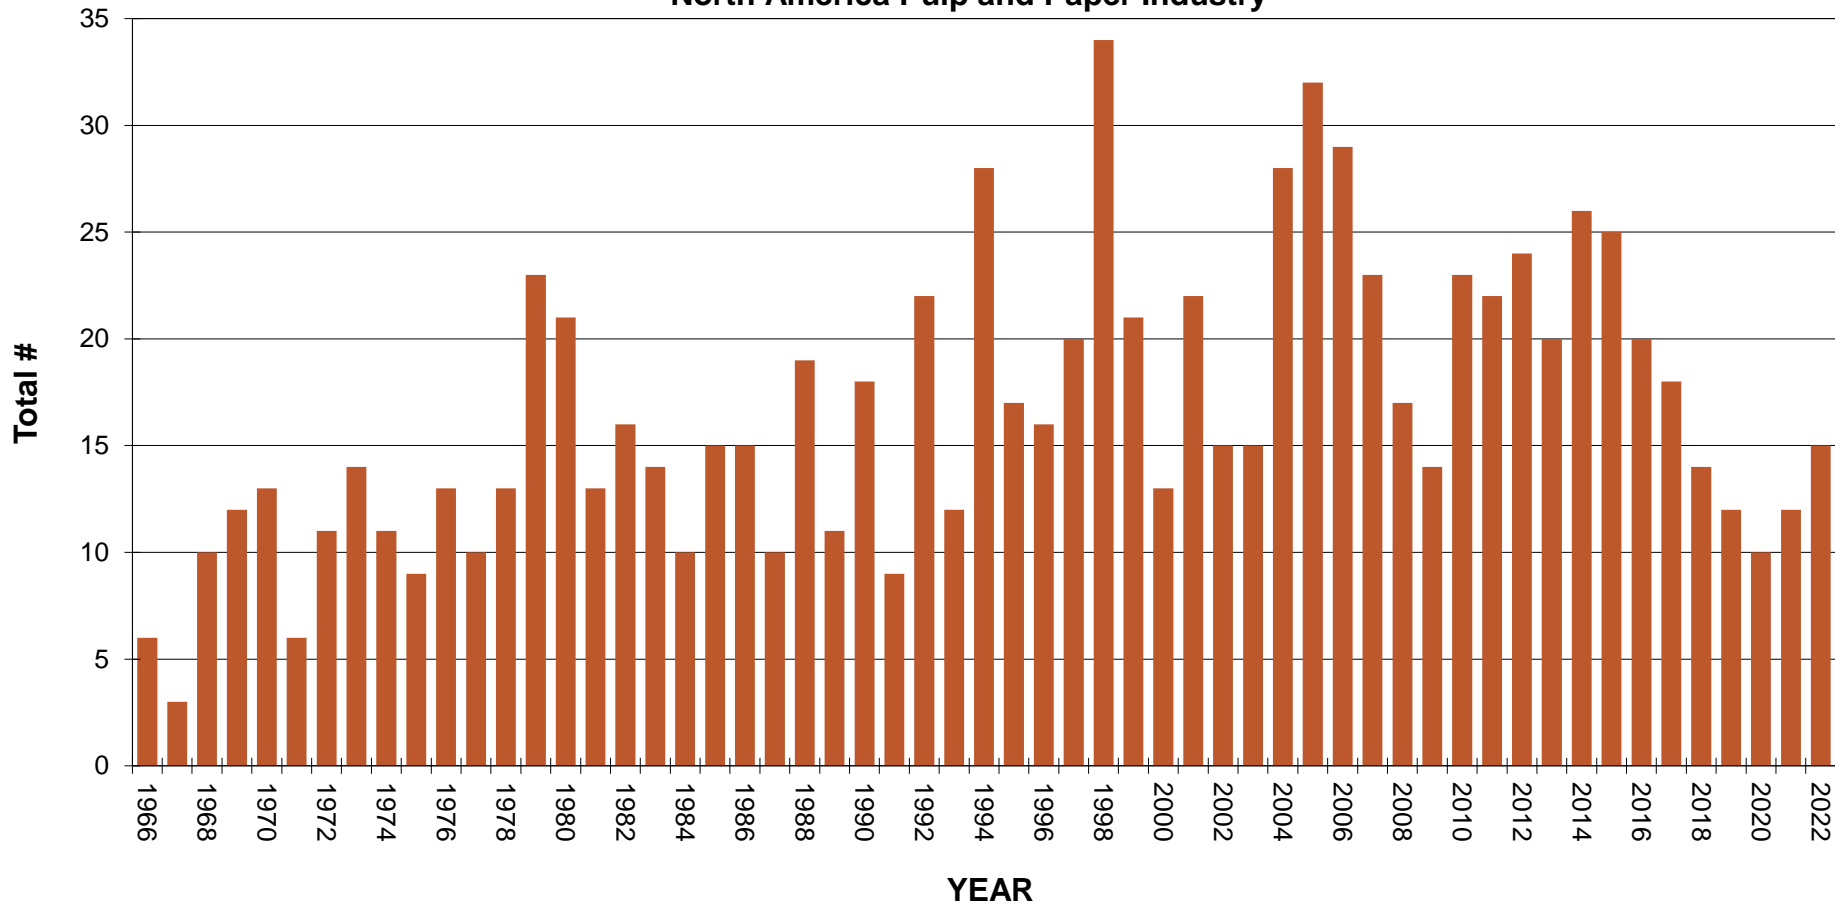
KRAFT RECOVERY BOILER CRITICAL INCIDENTS

North America Pulp and Paper Industry

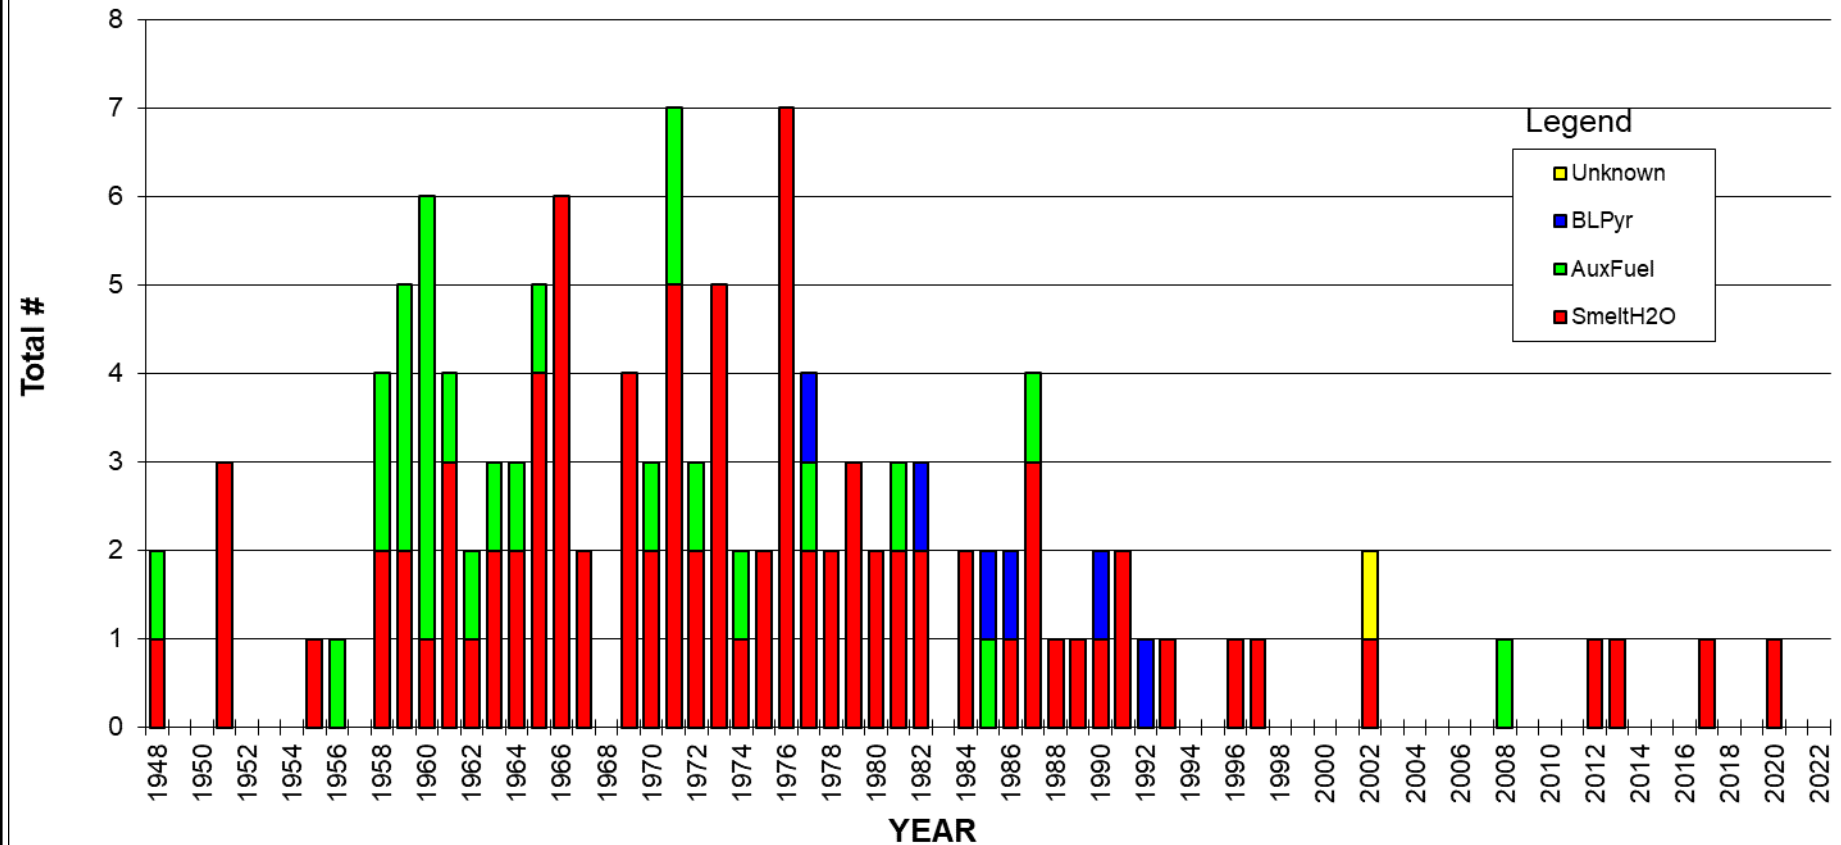
Boiler Explosion History

KRAFT RECOVERY BOILER EXPLOSIONS

North America Pulp and Paper Industry

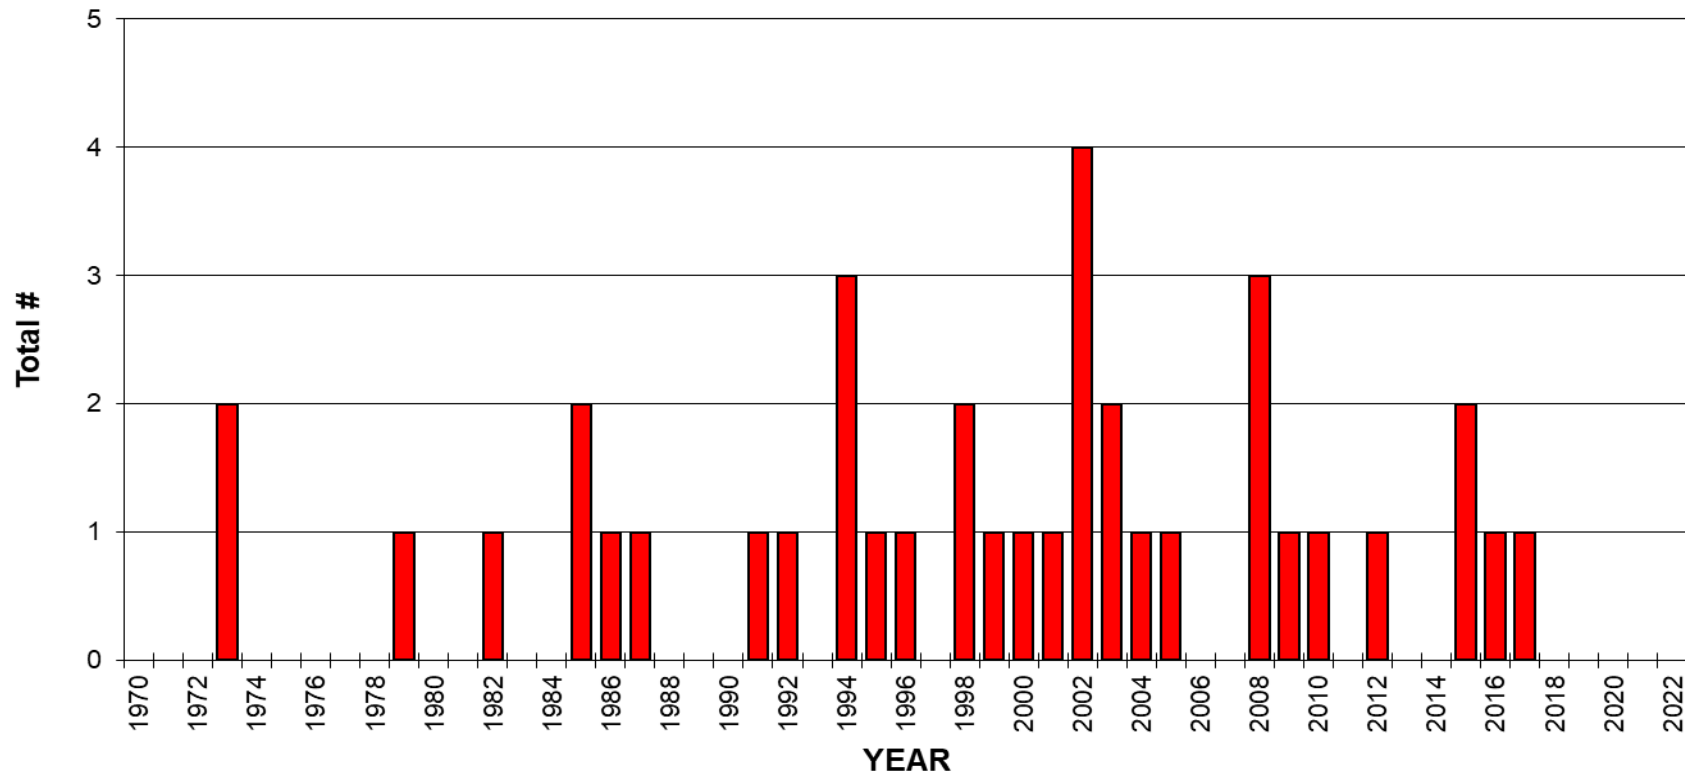
Dissolving Tank Explosions

KRAFT RECOVERY DISSOLVING TANK EXPLOSIONS

North America Pulp and Paper Industry
